California State University

Watershed Restoration Class—Spring, 2003

Pájaro River Watershed Flood Protection Plan

Pájaro River Watershed Flood Management Alternatives

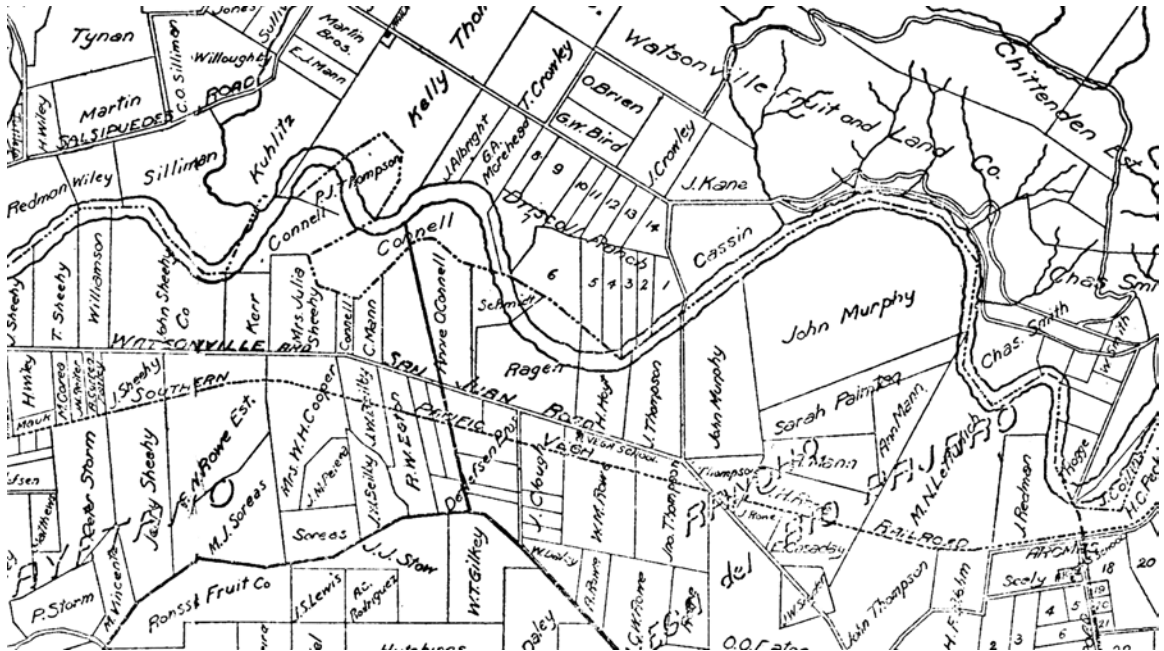
Map B. 1908 Parcel Map of a portion of the Lower Pájaro Valley showing the historic Vega area and dot-dashed County boundary as it exists today.

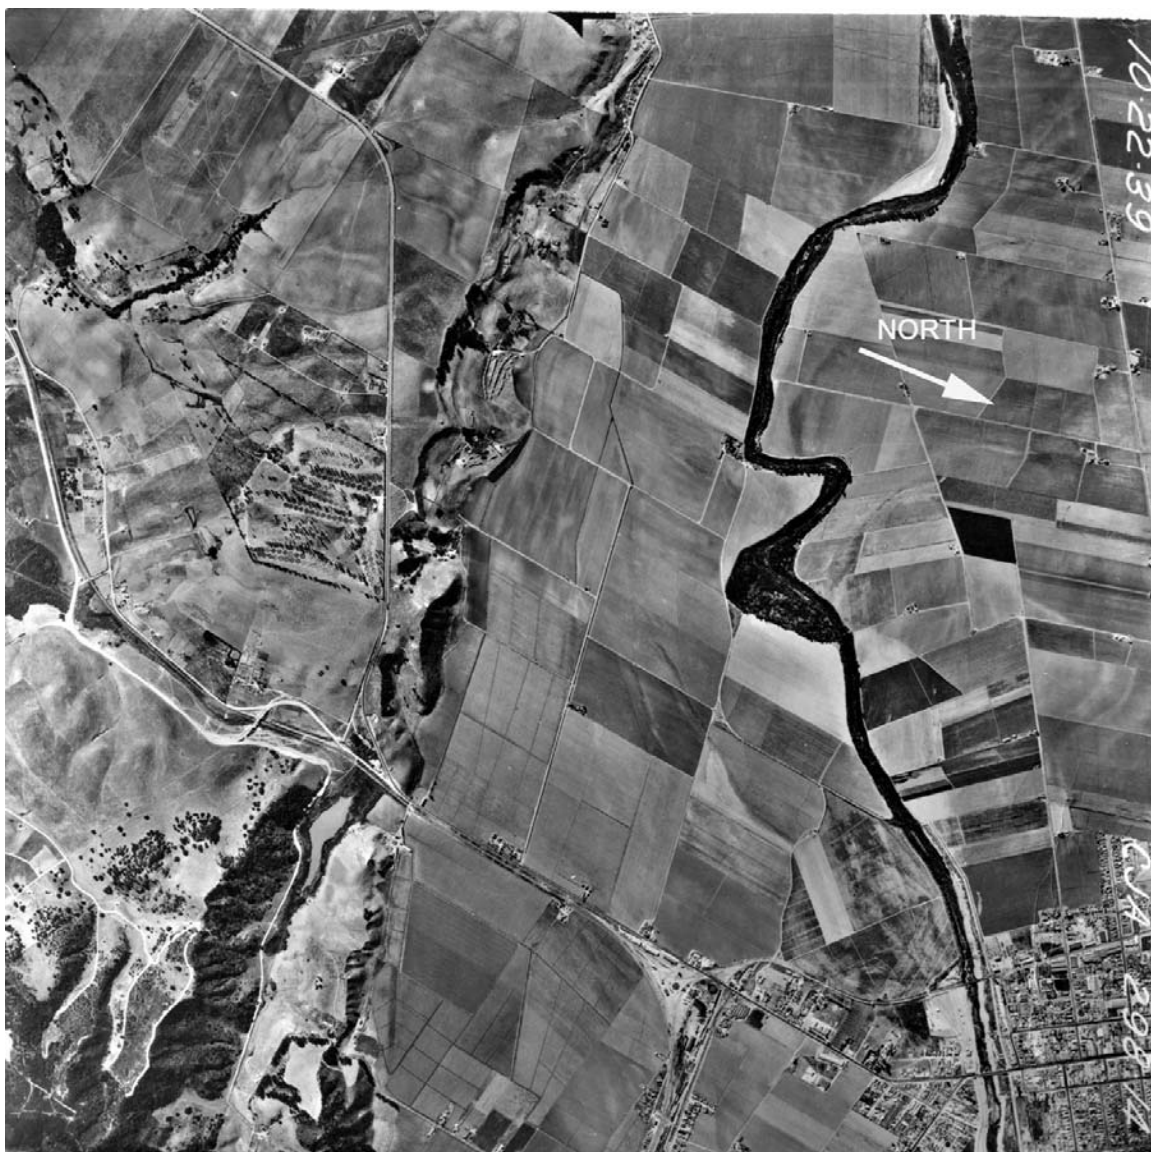
Figure 2 -- 1939 Photo of Lower Pájaro Valley. Watsonville in lower right. The landslides are readily seen at the position of Highway 1 today, near the center left of the photo. Also visible are the flow lines from past floods that impinge against the left (south) side of the valley.

Because the river that now flows through it did not form the lower Pájaro Valley, the watercourse is inherently unstable. Fluvial geomorphology recognizes this condition as “overfit”, with the natural watercourse being too big for its channel. Coupled to this inherent instability is the fact that the lower Pájaro Valley is traversed by the San Andreas Fault and the subsidiary Zayante-Vergeles fault system (R. Anderson, 1990). These are all among the most active terrestrial fault systems on the North American continent. The 1989 Loma Prieta earthquake apparently deformed the Pájaro River levee system (personal survey notes). Today the lowest point in the Pájaro Valley is not the Pájaro River but is a small overflow watercourse along the extreme south side of the lower valley. Based on undercutting of the hillsides at the south edge of the present Pájaro Valley and preserved cutoff meanders there, the southernmost edge of the valley has been the lowest point for at least several hundred to several thousand years (see Fig. 2).

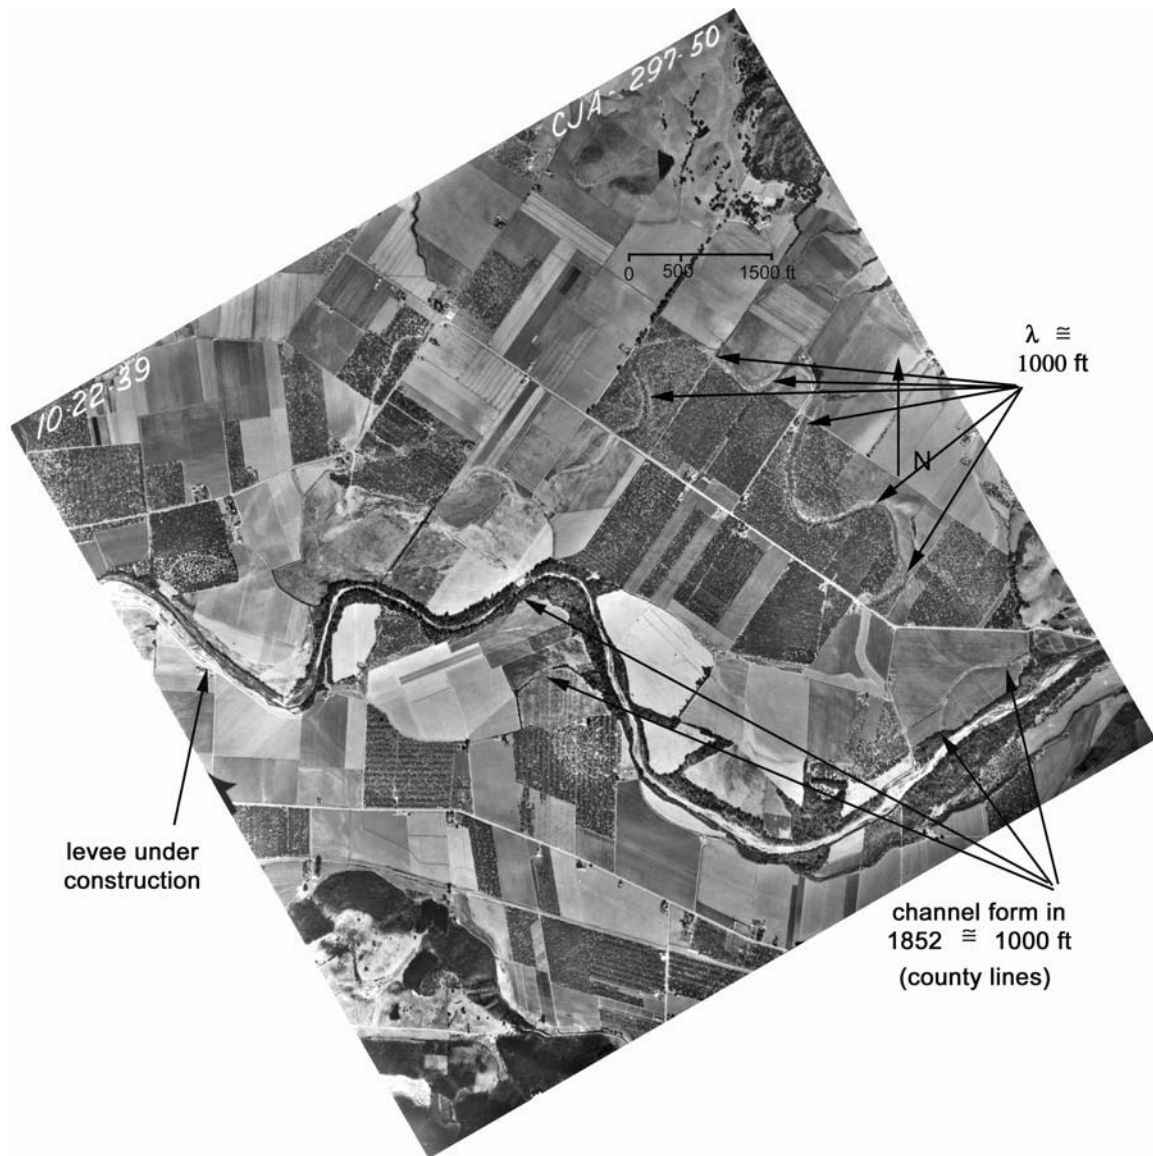
Figure 3 - 1938 Image of Lower Pájaro River showing natural meander patterns

It may be that in the Ranchero and early statehood period, the lower Pájaro River was channelized to try to restrict regular overbank flow in distributary channels so that land use could be made more efficient. Looking at the 1939 and earlier aerial photos, we still see clear evidence of those distributaries (cf Fig. 3). The earliest detailed topographic map (Capitola Quadrangle, 1912) shows “Watsonville Creek” that flows from the left bank of the Pájaro River across that river from Salsipuedes Creek in Watsonville, directly south near Salinas Road and into Elkhorn Slough. That channel is still there and still carries rainfall and flood overflow runoff to Moss Landing. Runoff from a major part of the townsite of Pájaro does not enter the Pájaro River today but flows via “Watsonville Creek” to Elkhorn Slough. The confusing topography was commented on by William Brewer in his diary in 1864 that noted that the flat valley looked like “an old lake filled in as is shown by the terraces around its sides.” (Farquhar, 1930). Olaf Jenkins identifies a “Lake Pájaro” and “Lake Aromitas” in the old lower Pájaro Valley (1973).
